# HINCKLEY DAM

## PHASE I INSPECTION REPORT NATIONAL DAM SAFETY PROGRAM

NY 00181

Name of Dam: Hinckley Dam  
County and State: Herkimer County, New York State  
Inventory Number: NY 00181

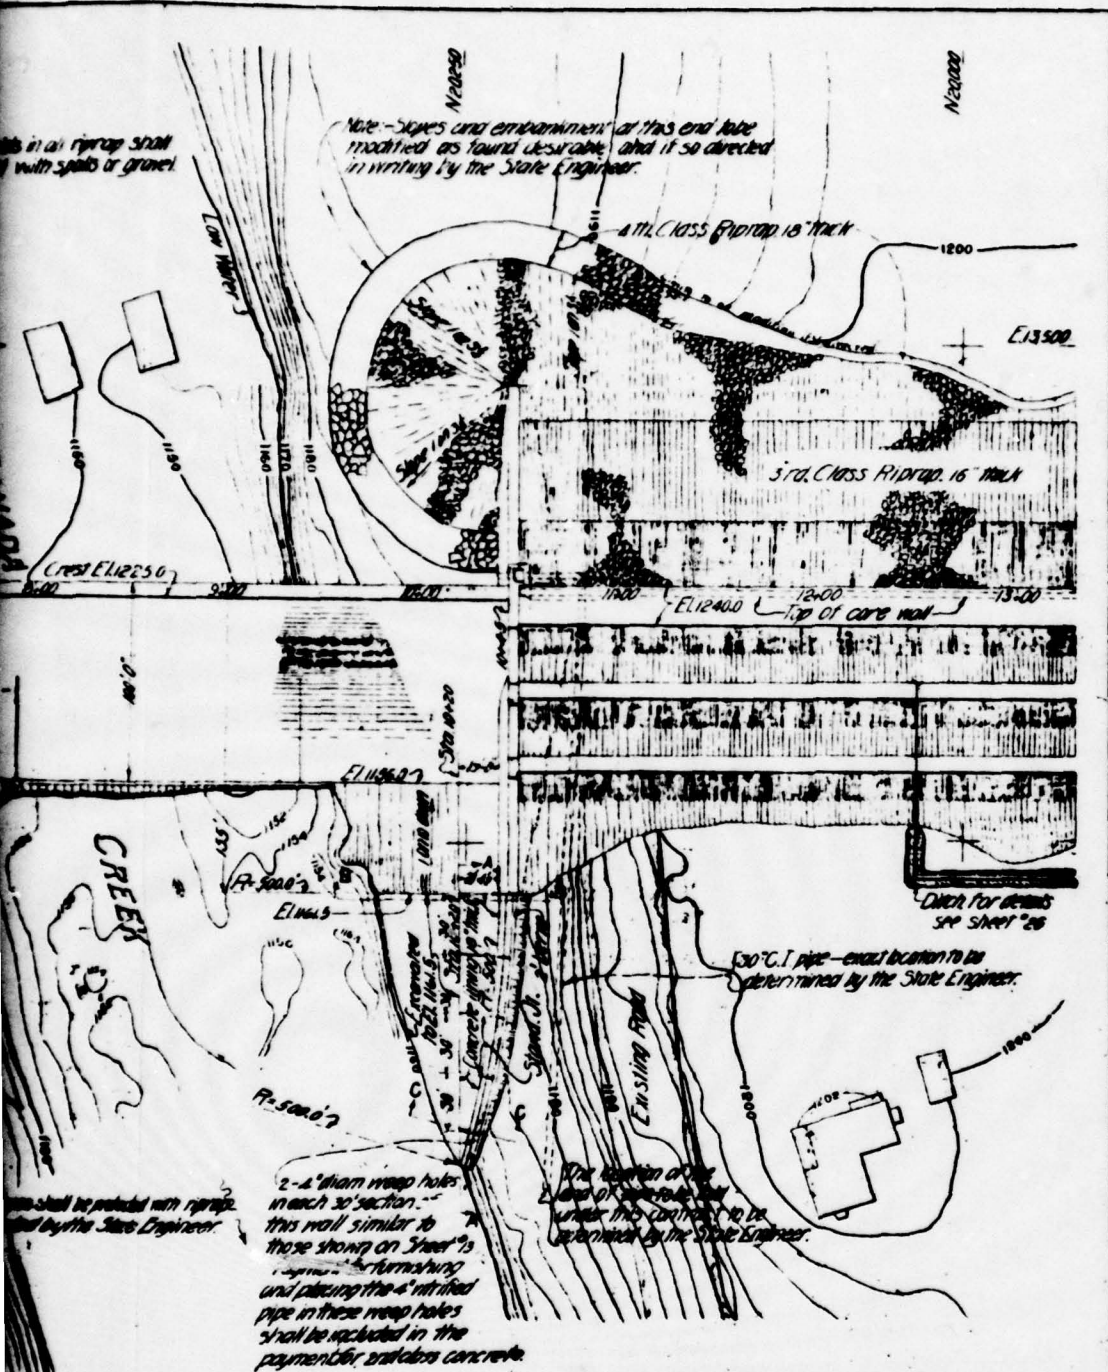
**FIGURE 2**  
**Contract No. 50.**

The downstream slope of the north embankment is provided with two benches. The benches are sloped towards the center of the embankment to provide for surface drainage. A swale is constructed near the center of the embankment. The swale extends from the upper bench to a ditch downstream of the toe of the embankment. Standpipes were noted on each bench about 30 feet from the north wingwall. The water levels below the upper and lower benches were measured at 24 feet and 11.8 feet respectively. Just above the toe of the embankment is an area of stone fill over a fabric filter extending about 20 feet up the embankment. The area extends laterally about 75 feet from the north wingwall, and is provided with a 6 inch corrugated metal underdrain pipe. The pipe terminates at a drainage ditch downstream of the toe. Flow from the pipe was clear and estimated at 1 gpm. See Figure 2 for the approximate location of the standpipes and stone fill.

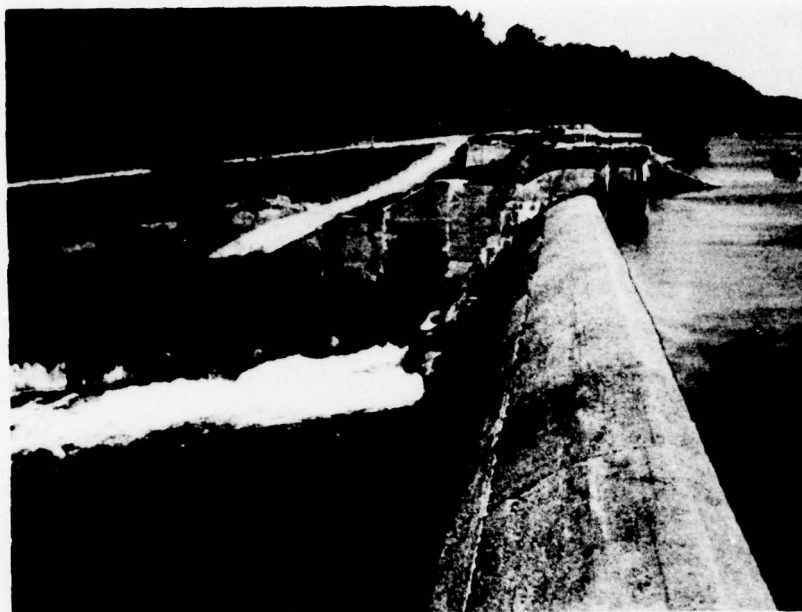
NORTH ABUTMENT, OUTLET WORKS, AND SPILLWAY

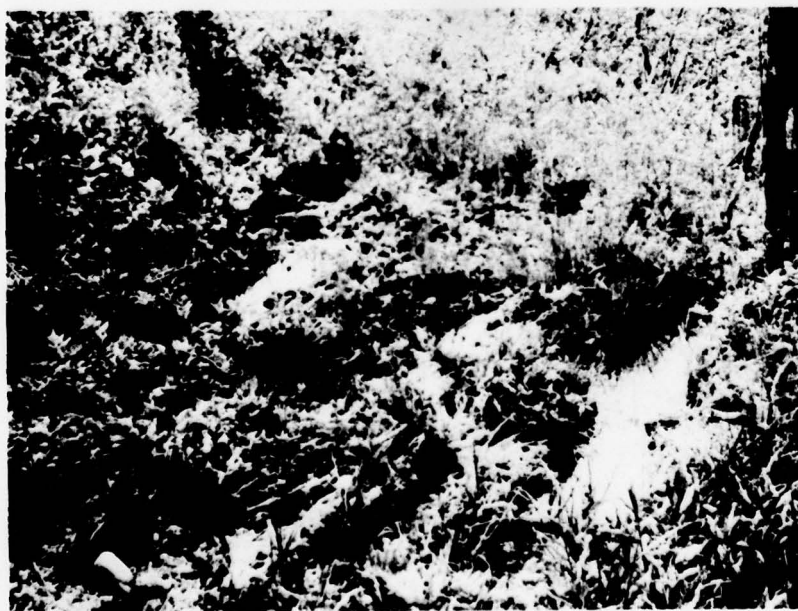
SATURATED AREA WITH STANDING WATER AT TOE OF EMBANKMENT

Minor seepage was noted at the toe  
of both earth embankments. At most  
locations, the seepage water was  
observed to have a rust or brown  
discoloration.

A boring program should be initiated immediately at several selected sections of the embankment to include, but not be limited to, determination of the composition and in situ properties of the embankment and foundation materials, to establish if they are satisfactory for the embankment core wall and foundation as designed and constructed, and to detect possible fines migration. Piezometers should be installed in the boreholes to evaluate pore pressure development throughout the embankment. The results of these investigations should be used to perform seepage and stability analyses for the embankments.

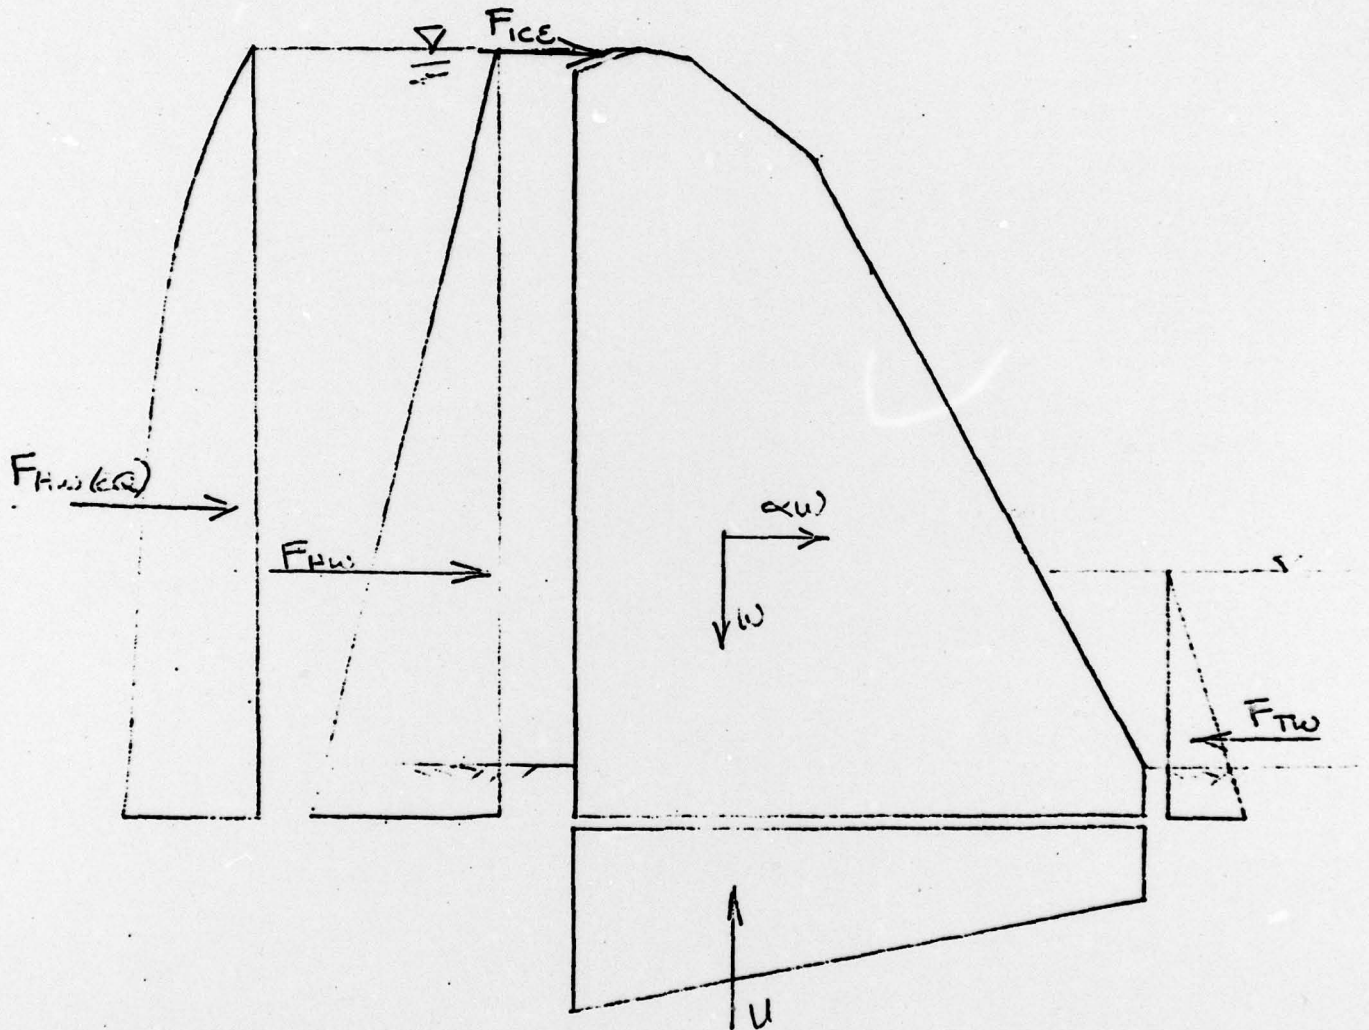
GENERALIZED LOADING FOR SPILLWAY

Review of the stability analyses for the spillway indicates that satisfactory factors of safety are present for the normal pool and ice load conditions. For the PMF loading, the resultant of forces is outside the middle third of the base.

NET HORIZONTAL FORCE= 247.94 KIPS  
NET VERTICAL FORCE= 345.54 KIPS  
NET MOMENT= 6309.35KIP-Feet  
X-BAR OF FOUNDATION REACTION= 19.26 FEET  
ECCENTRICITY OF FOUNDATION REACTION FROM CENTER= 12.74 FEET  
\*\*\*\*\*FOUNDATION REACTION NOT IN CENTRAL THIRD OF BASE\*\*\*\*\*TENSION AT HEEL OF DAM\*\*\*\*\*  
FOUNDATION REACTION PRESSURES\*\*\*\*\*TOE= 86.42 PSI\*\*\*\*\*HEEL= -9.02 PSI\*\*\*\*\*  
OVERTURNING FACTOR OF SAFETY= 1.44  
SLIDING WITH SHEAR FACTOR OF SAFETY= .72  
DEVELOPED FRICTION FACTOR (NO SHEAR)= .84  
SLIDING WITH SHEAR FACTOR OF SAFETY= 4.44(SHEAR ACROSS FULL BASE WIDTH)

X-BAR OF FOUNDATION REACTION= 12.86 FEET  
ECCENTRICITY OF FOUNDATION REACTION FROM CENTER= 18.92 FEET  
\*\*\*\*\*FOUNDATION REACTION NOT IN CENTRAL THIRD OF BASE\*\*\*\*\*  
FOUNDATION REACTION PRESSURES= 49.56 PSF @HEEL= -26.26 PSF @TOE  
OVERTURNING FACTOR OF SAFETY= 1.19  
SLIDING FACTOR OF SAFETY= .69  
DEVELOPED FRICTION FACTOR (NO SHEAR)= .87  
SLIDING WITH SHEAR FACTOR OF SAFETY= 4.31(SHEAR ACROSS FULL BASE WIDTH)
